Repairing procedure for the yellow Zero EMF heating cable

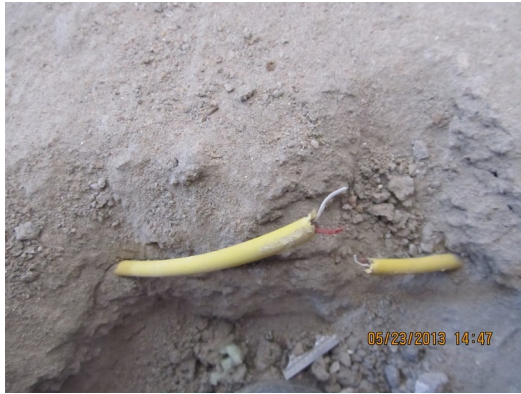
1. Sometimes such problems occur with installed cable covered with cement. Here is how to deal with such problems.
